2012 Mark O. Hatfield Preservation Project

Portland, Oregon

a rehabilitation project to repair and protect the structure, replace and upgrade building components, increase energy efficiency, and improve the health and comfort of residents.

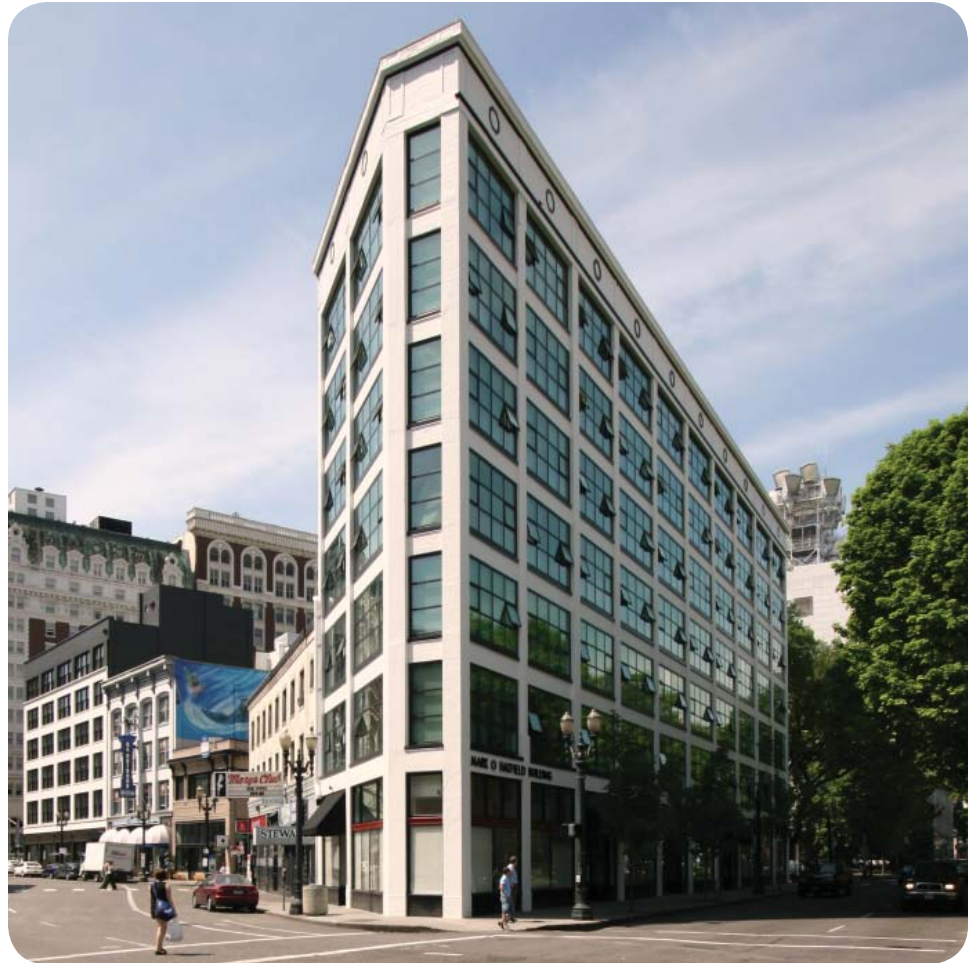
Hatfield Building in 2012, window replacement and exterior work complete, corner of West Burnside & Broadway Streets
source: Central City Concern

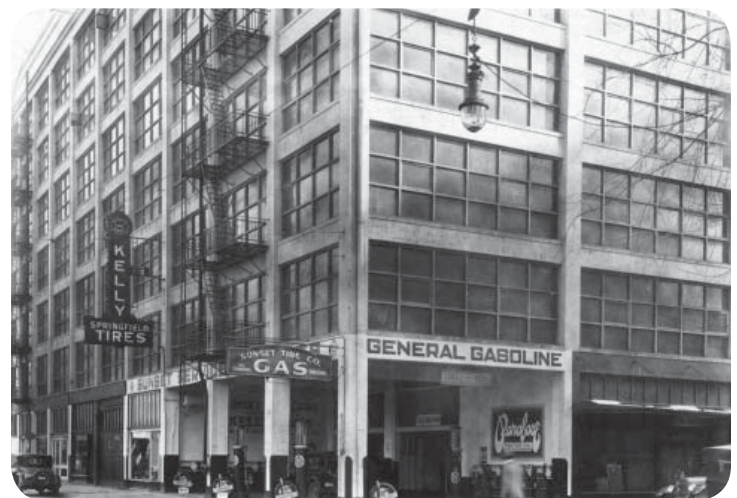
Hatfield Building in 1928, then known as the Lowengart Building, corner of 8th Avenue & West Burnside Street before north 20' portion of building was removed in 1931 to widen Burnside Street.
source: City of Portland Archives, Oregon, A2000-033.
